Shakespeare Park
Avon Road
Braunstone

**Phase II Exploratory Investigation
For
Braunstone Town Council**

Project No: 37327		Date: 18th December 2017	
Issue/revision	Prepared by	Checked By	Approved By
	Nina Copson BSc (Hons) MSc FGS Geo-Environmental Engineer	Jason Hollands BSc (Hons) MSc MEnvSc CGeol FGS Director	Jason Hollands BSc (Hons) MSc MEnvSc CGeol FGS Director

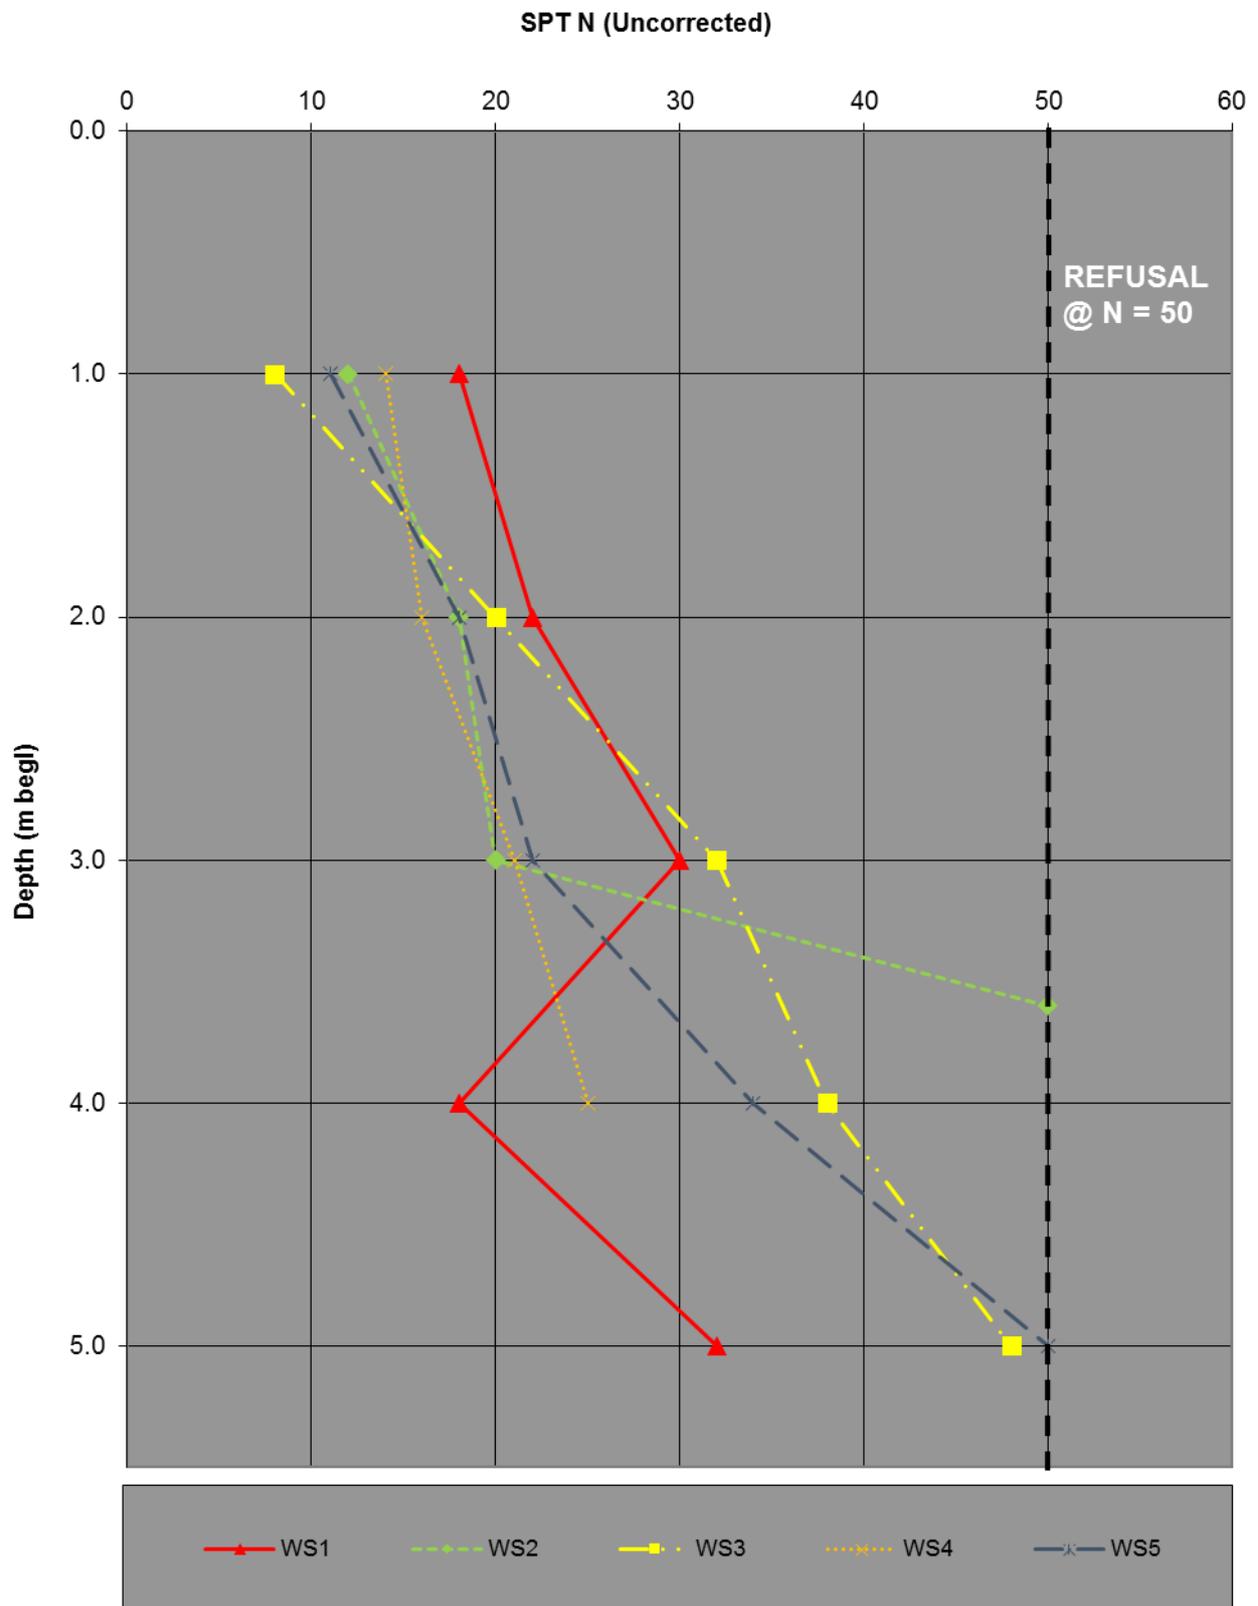
Shakespeare Park, Avon Road, Braunstone SPT N Values Vs Depth (m begl)

Within the cohesive superficial strata (Oadby Member) encountered in the boreholes, SPT 'N' values were found to range between 8 and 18 at 1m depth, with 'N' values ranging between 16 and 32 at depths of between 2m and 3m begl. This confirms the general soil description with strengths of initially firm to stiff, becoming very stiff (to hard clay) with depth.

A summary of the SPT testing undertaken at the site is included in the chart presented on Page 9 and presented on the exploratory hole logs in Appendix V.

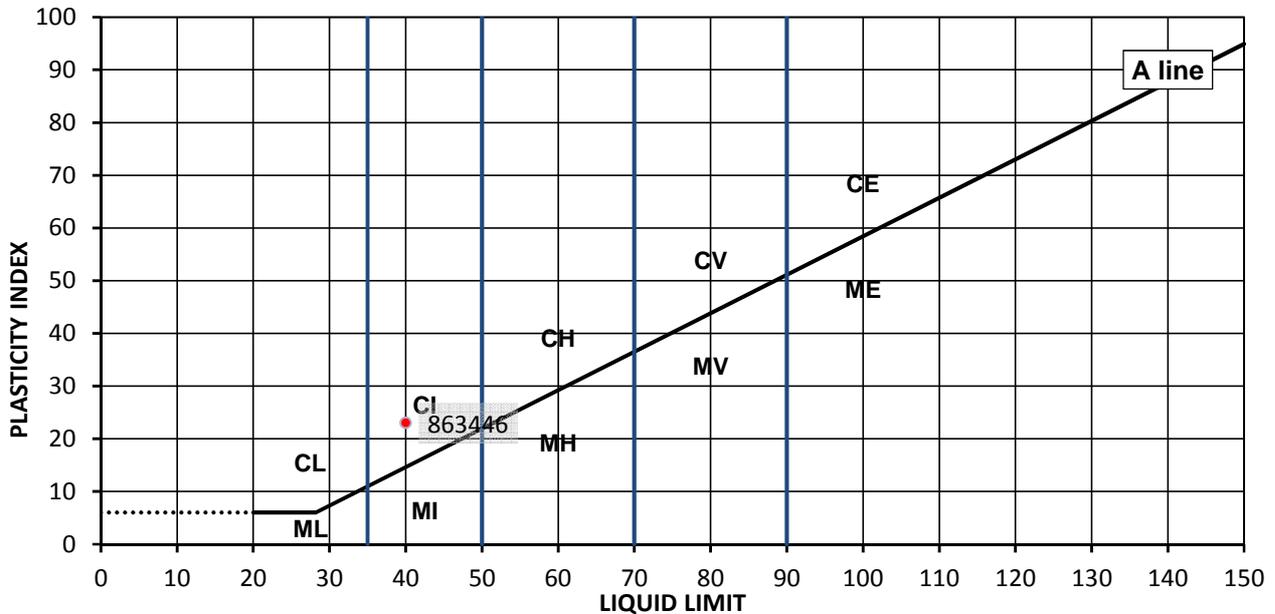
As Received Moisture Content [%]	Liquid Limit [%]	Plastic Limit [%]	Plasticity Index [%]	% Passing 425µm BS Test Sieve
18	40	17	23	98

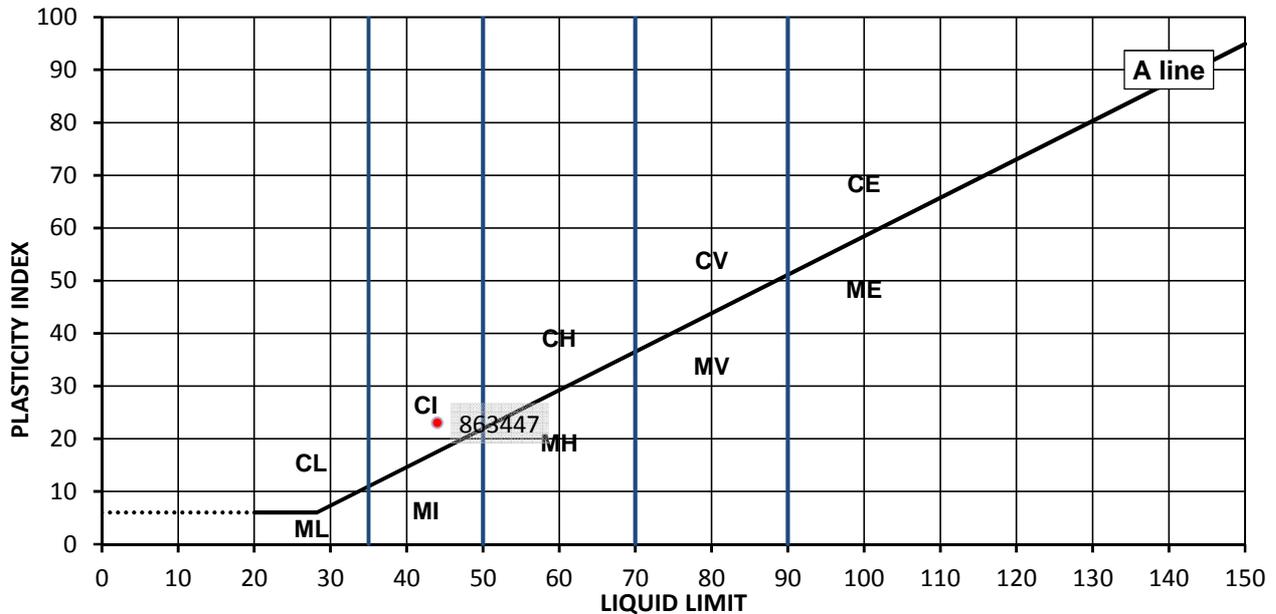
As Received Moisture Content [%]	Liquid Limit [%]	Plastic Limit [%]	Plasticity Index [%]	% Passing 425µm BS Test Sieve
15	44	21	23	95

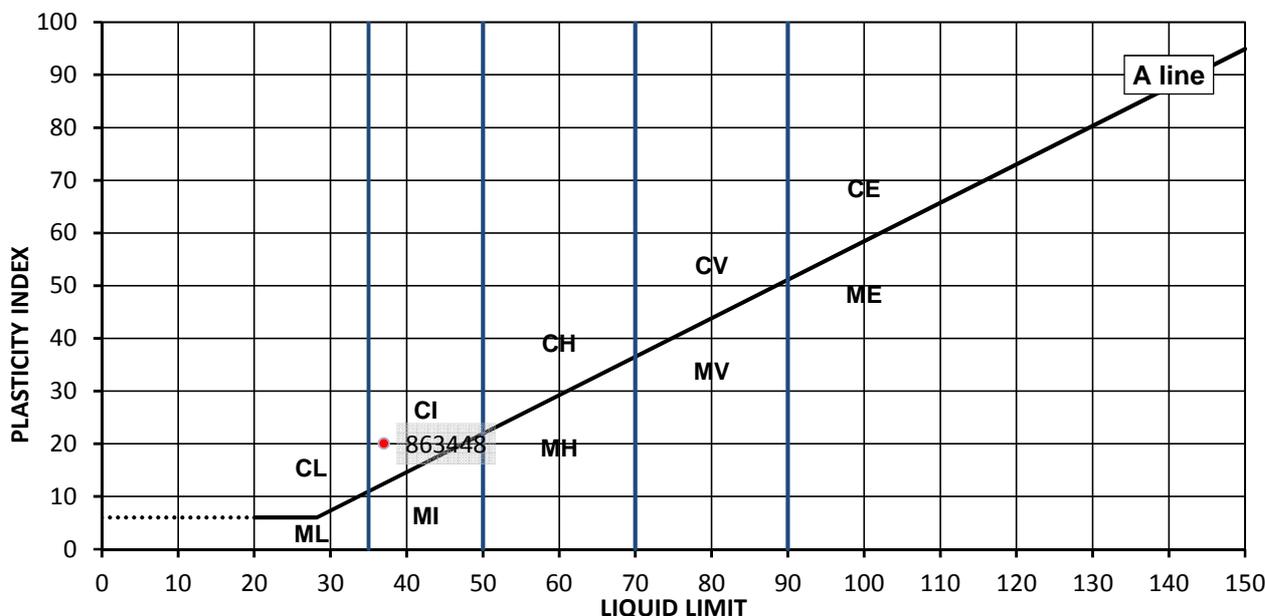
As Received Moisture Content [%]	Liquid Limit [%]	Plastic Limit [%]	Plasticity Index [%]	% Passing 425µm BS Test Sieve
18	37	17	20	99

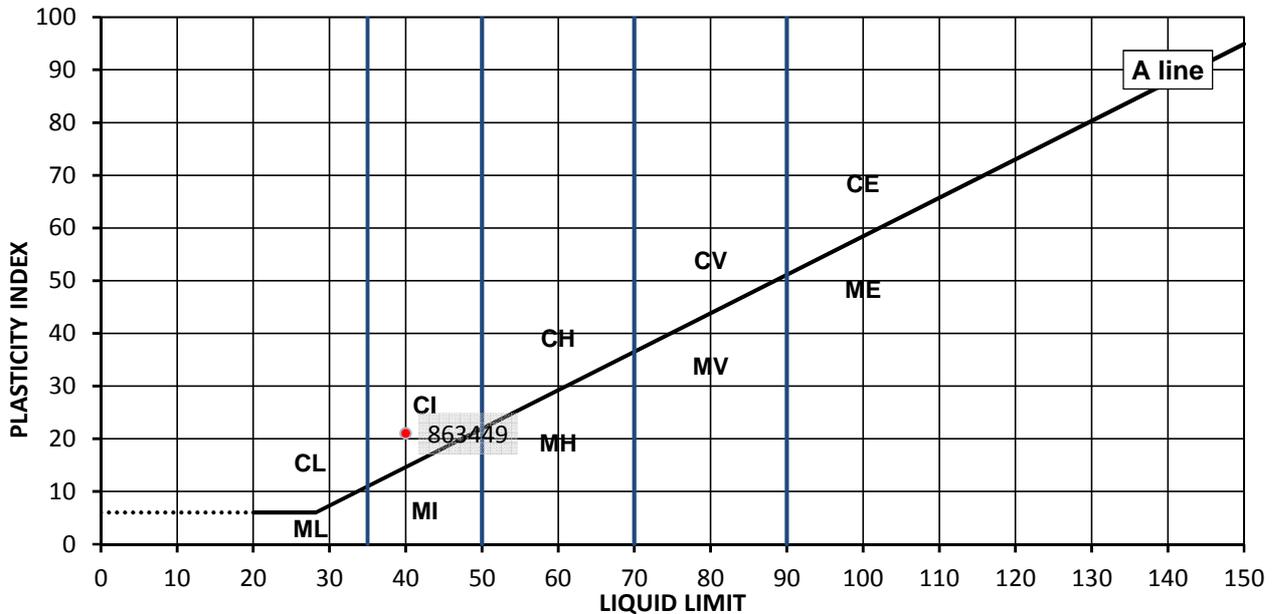
As Received Moisture Content [%]	Liquid Limit [%]	Plastic Limit [%]	Plasticity Index [%]	% Passing 425µm BS Test Sieve
18	40	19	21	95

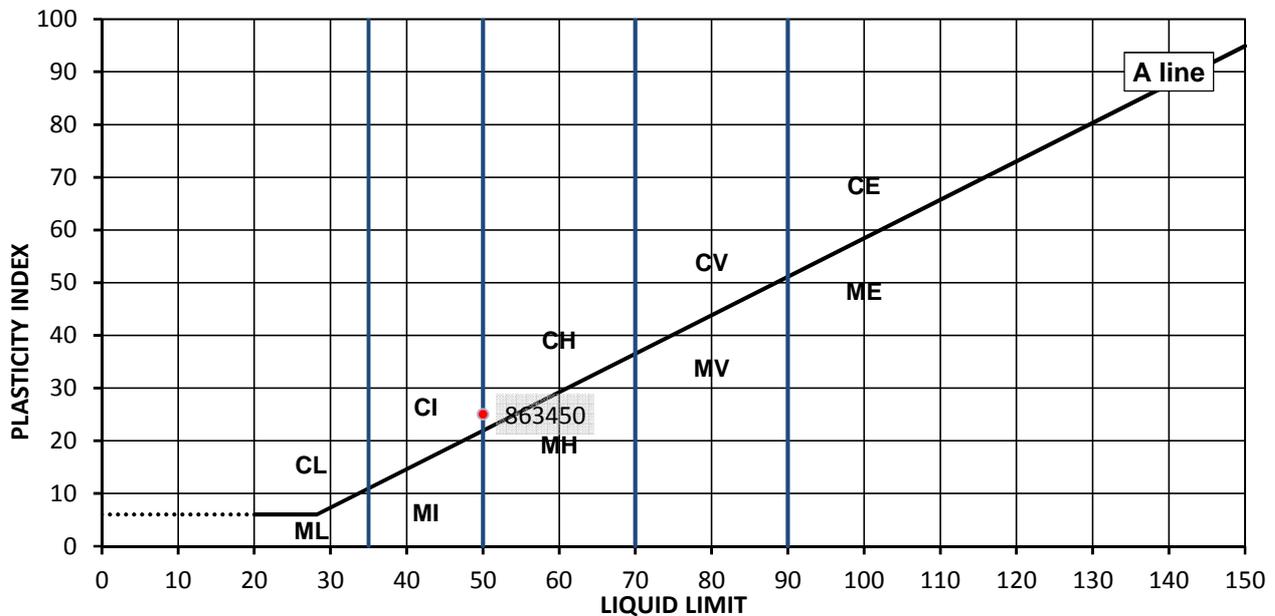
As Received Moisture Content [%]	Liquid Limit [%]	Plastic Limit [%]	Plasticity Index [%]	% Passing 425µm BS Test Sieve
12	50	25	25	88

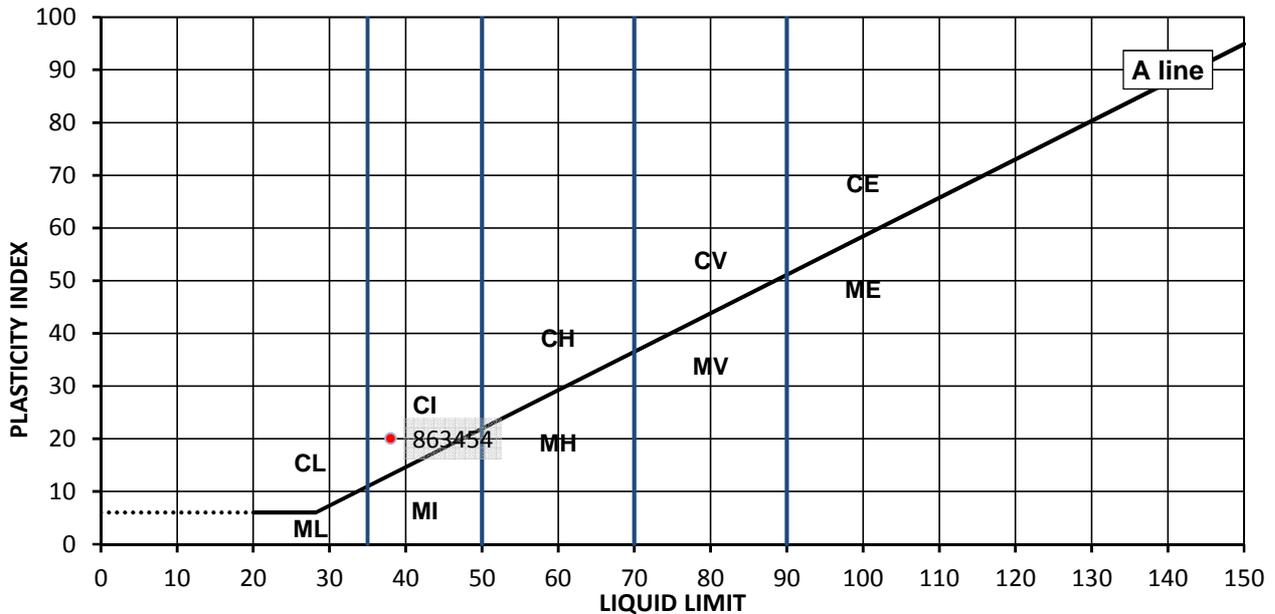
As Received Moisture Content [%]	Liquid Limit [%]	Plastic Limit [%]	Plasticity Index [%]	% Passing 425µm BS Test Sieve
16	38	18	20	95

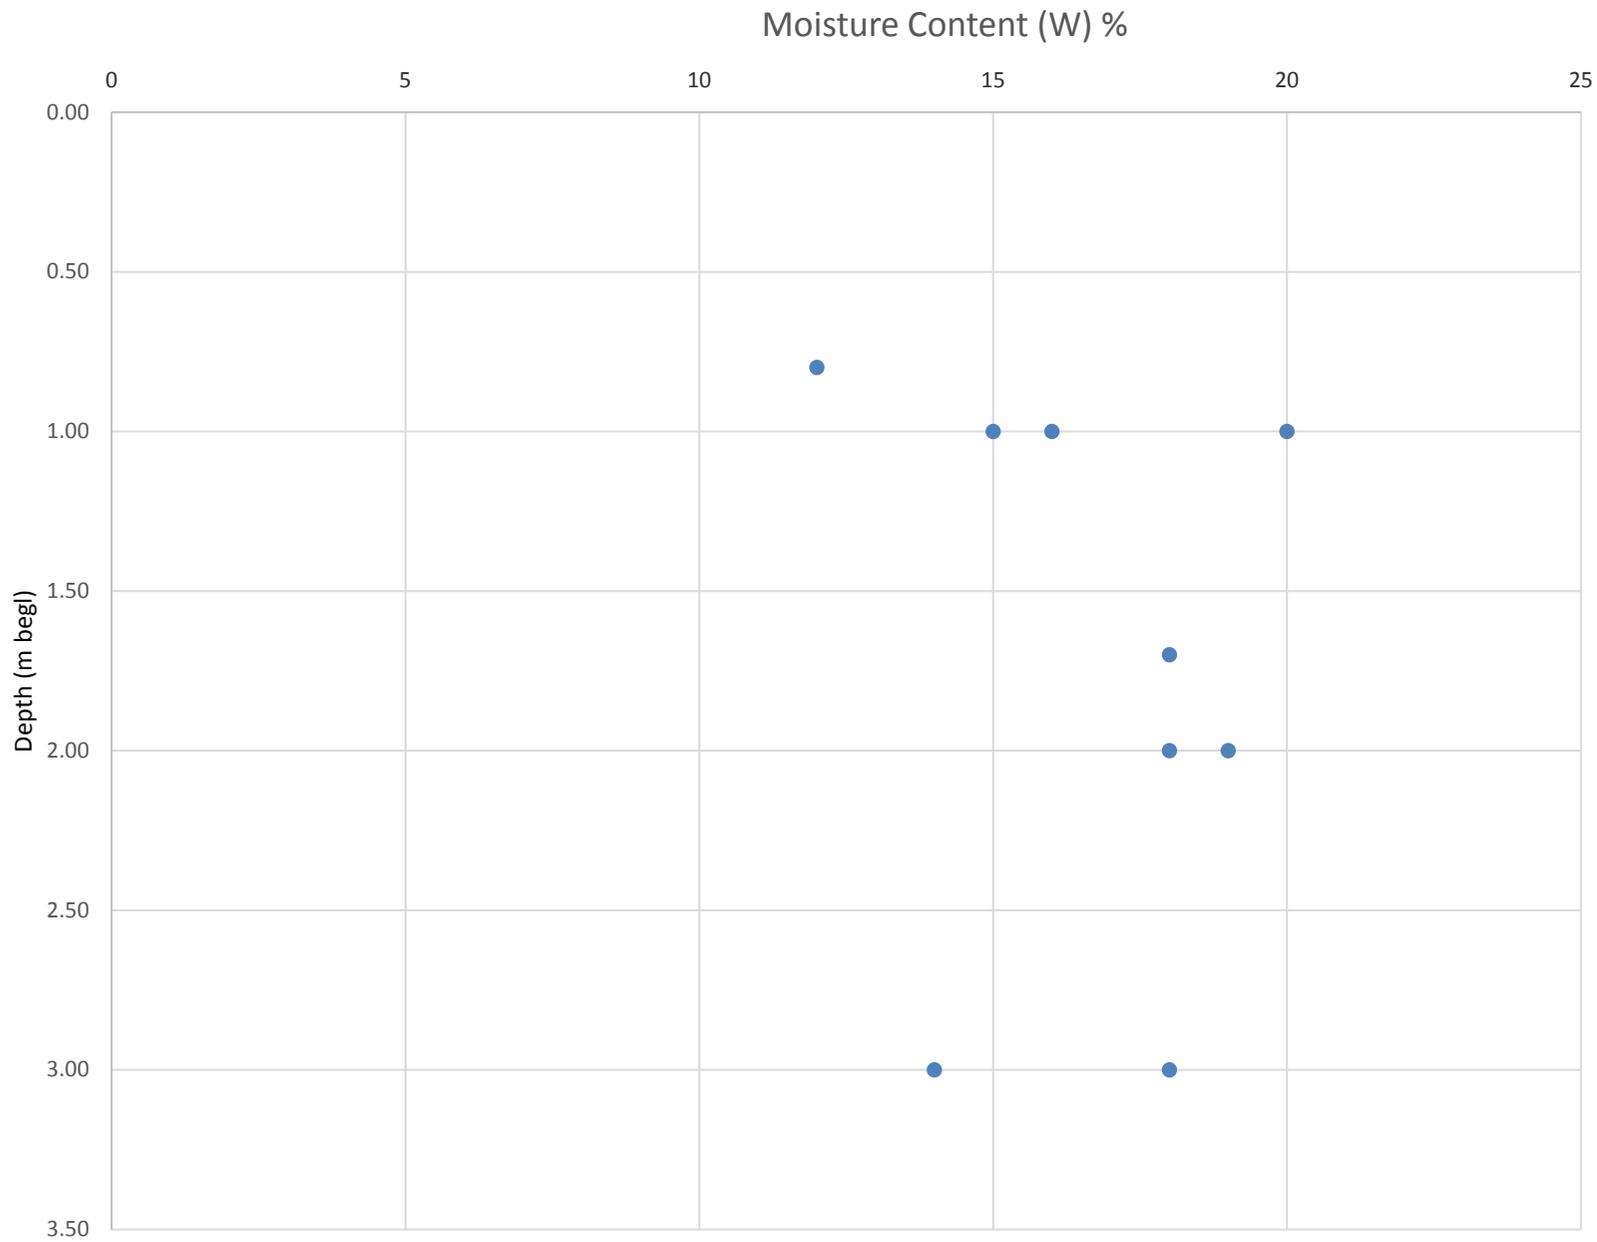
● Moisture Content (W) %

Exploratory Hole No.	Depth Top (m begl)	Moisture Content (W) %	Liquid Limit (WL) %	Plastic Limit (Wp) %	Plasticity Index (Ip) %	Ratio W/WL	Liquidity Index (LI)
WS1	1.70	18	40	17	23	0.45	0.04
WS2	1.00	15	44	21	23	0.34	-0.26
WS2	2.00	18	37	17	20	0.49	0.05
WS2	3.00	18	40	19	21	0.45	-0.05
WS4	0.80	12	50	25	25	0.24	-0.52
WS6	1.00	16	38	18	20	0.42	-0.10
WS5	1.00	20					
WS5	2.00	19					
WS5	3.00	14

Charts showing Moisture Content versus depth, the ratio of W/W_1 and Liquidity Index are included in Appendix VIII.

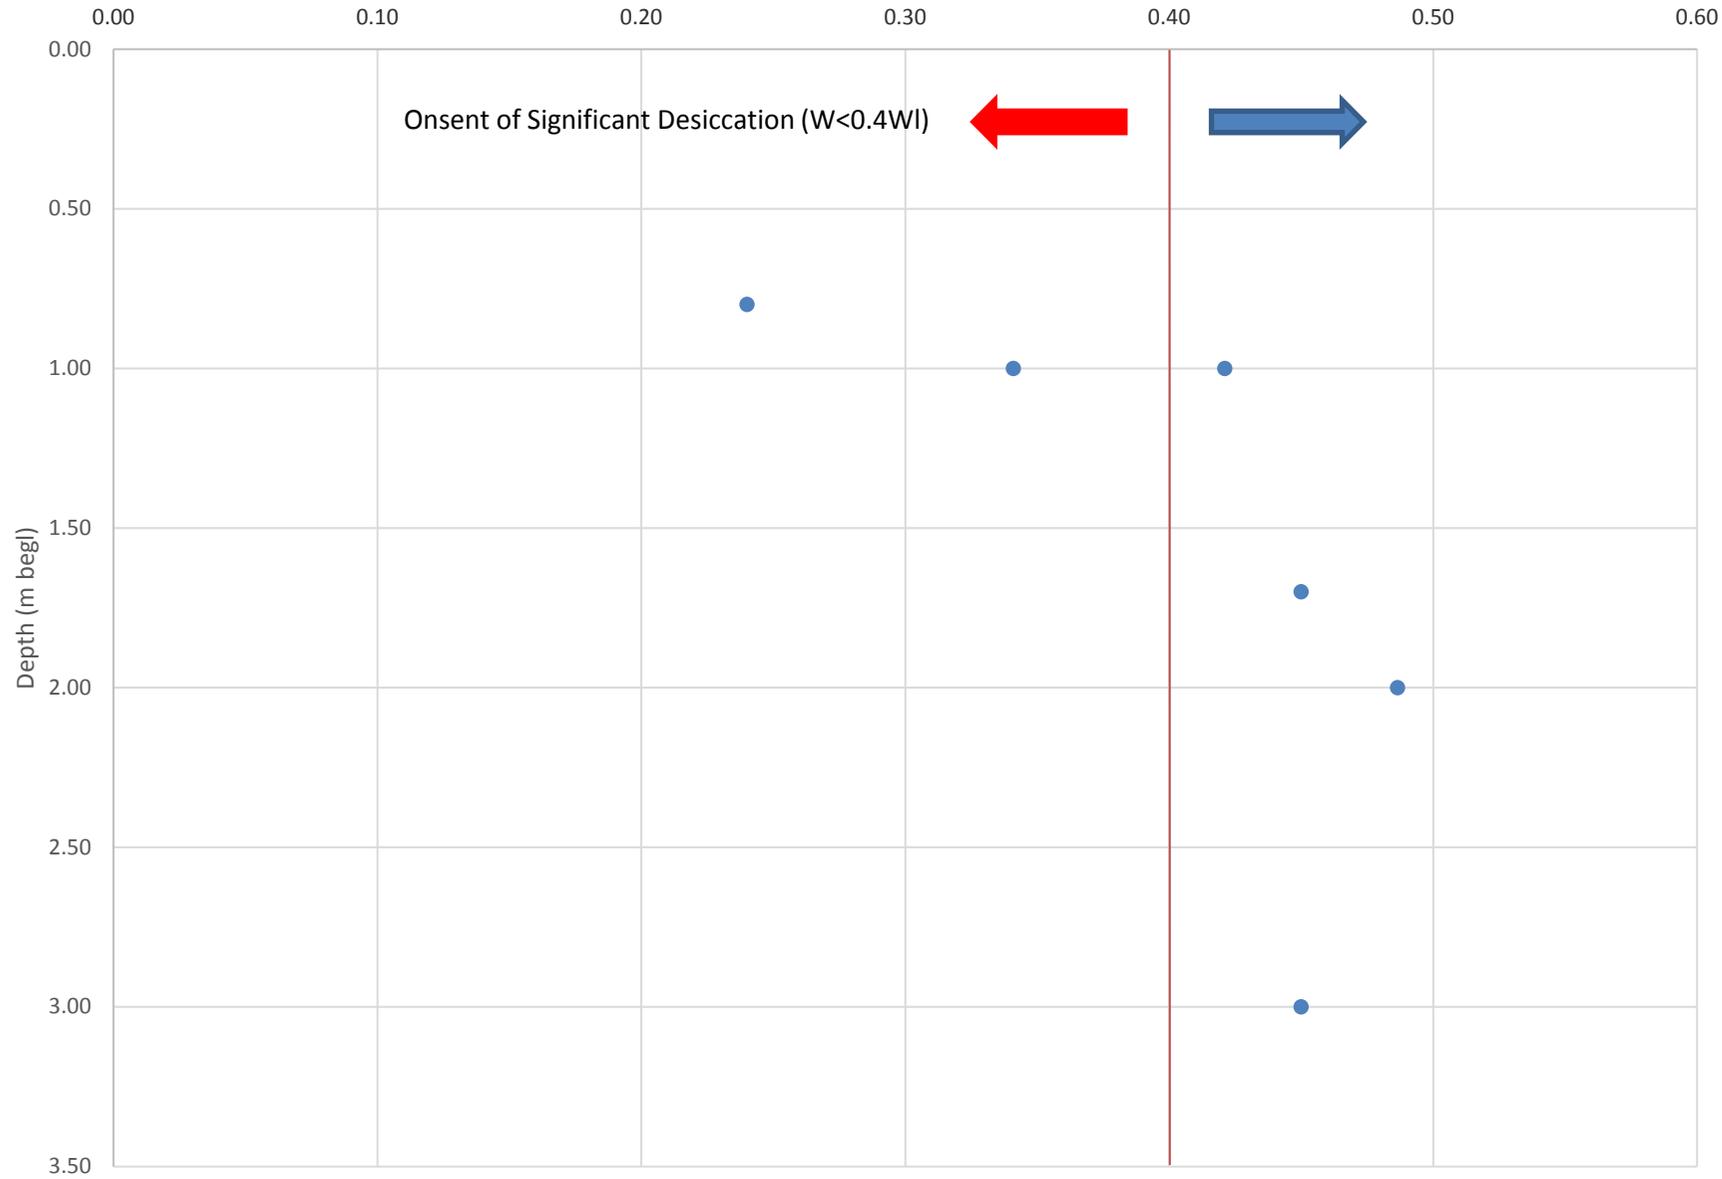
Ratio Moisture Content (W)/Liquid Limit (WL)

The Ratio of W to W_1 was found to range between 0.49 (highest) and 0.24 (lowest). The ratio of W to W_1 was found to be below 0.4 in 2 of the 6No. samples tested (33% of the samples).

Analysis of the moisture content and plasticity index testing was revealed that the Clay soils were desiccated with $W < 0.4W_l$ in 33% of the samples tested. Furthermore, the Liquidity Index revealed negative values in 4No of the 6No. samples tested.

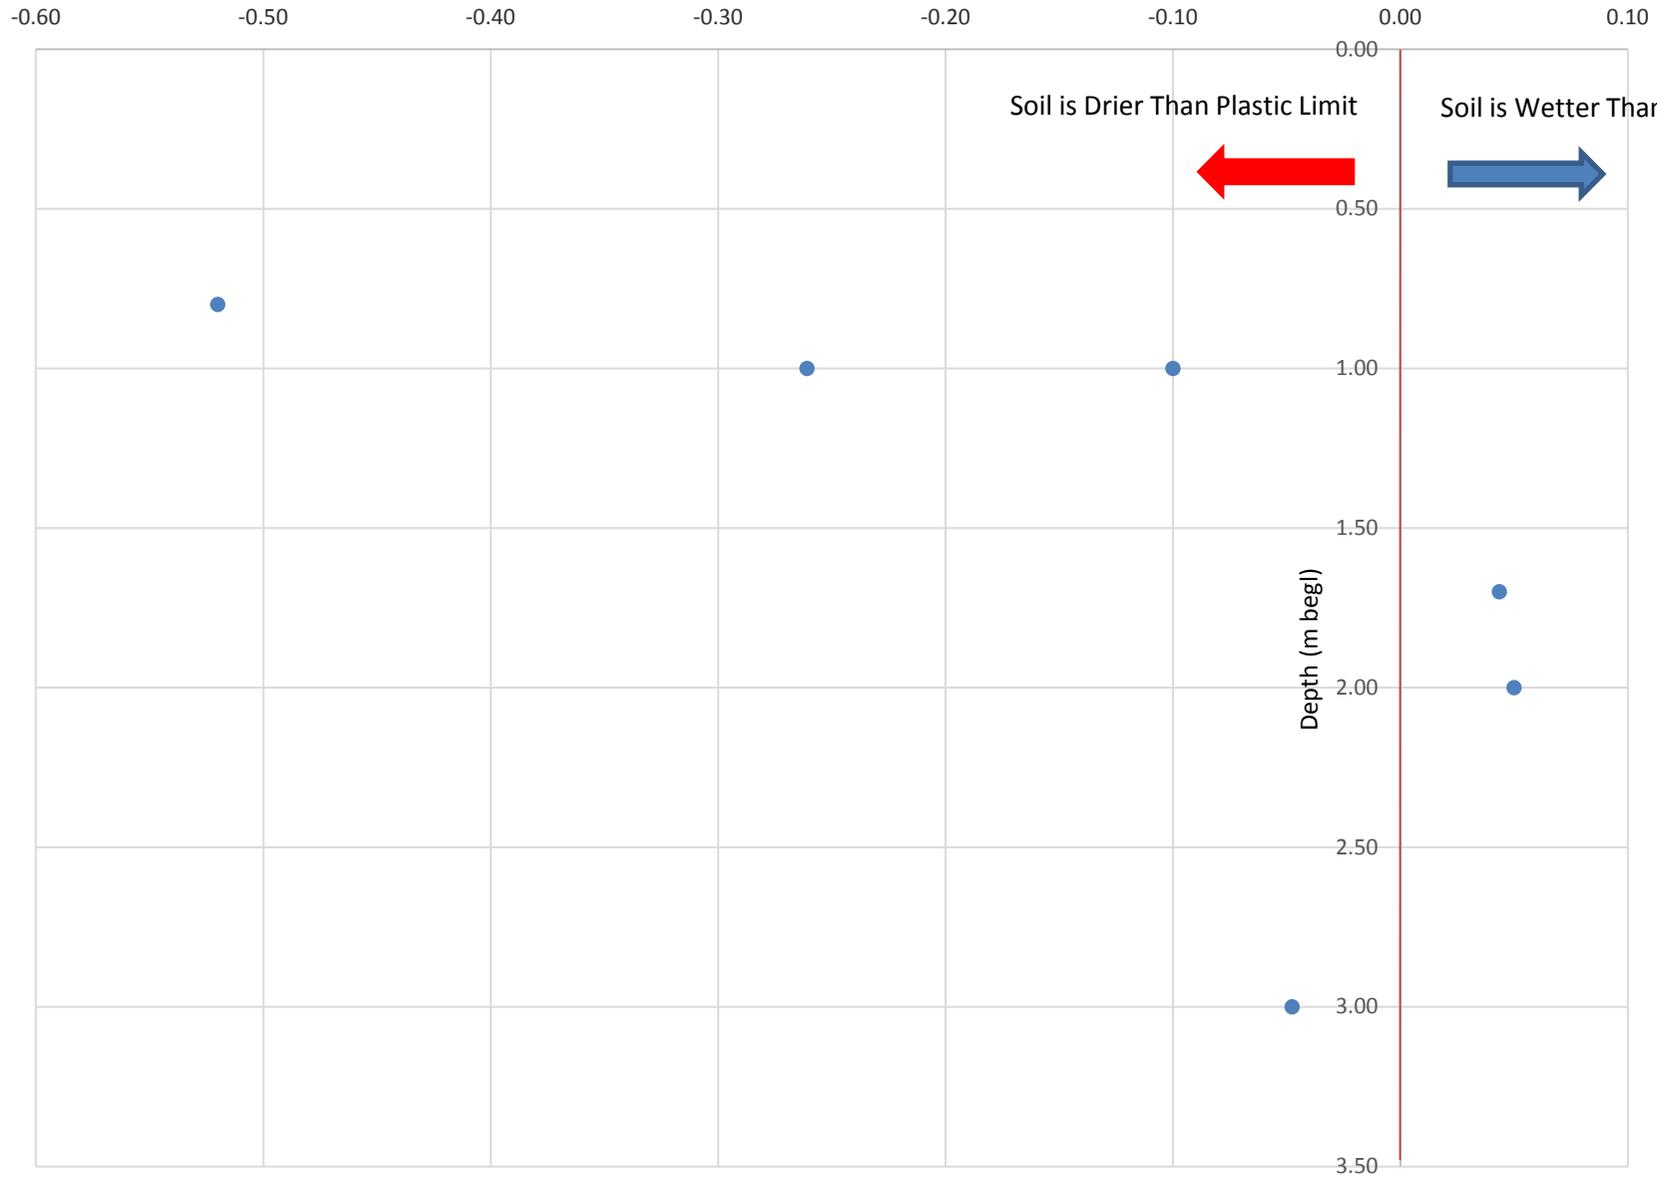
Liquidity Index (II)

The Liquidity Index was calculated for the 6No. samples. The Liquidity Index was found to range between 0.05 (highest) and -0.52 (lowest). The liquidity index was found to be lower than 0 (i.e. negative) in 4 of the 6No. samples (66% of the samples).
