Braunstone Village Conservation Area
CHARACTER APPRAISAL

2024

Braunstone Village, Blaby Conservation Area

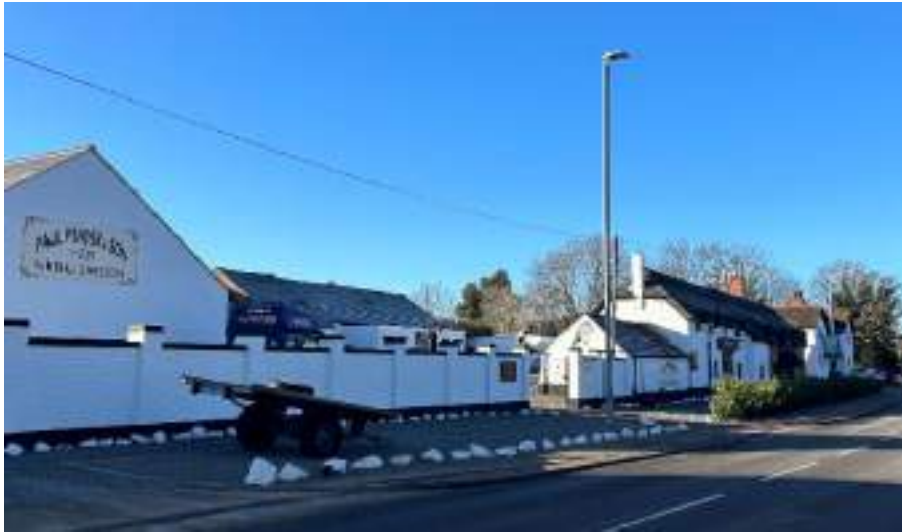
Image 8: The Shakespeare.

- 7.7 At the south-eastern end of the conservation is a complex of buildings, formally known as Ashleigh Farm, it is now called **The Shakespeare**. To the front of the plot, running parallel to the highway is the former farmhouse, the oldest sections of which is timber frame construction dating to the mid-17th century, with later alterations and extensions. The porch has the year “1655” recorded on its moulded lintel. The timber framed section contains brick infill in a mix of stretcher bond and herringbone patterns, and the building has been extended south in brick. The roof is thatched with a scalloped ridge and several thatched dormers. The Shakespeare and its curtilage are Grade II listed, designated in 1987.

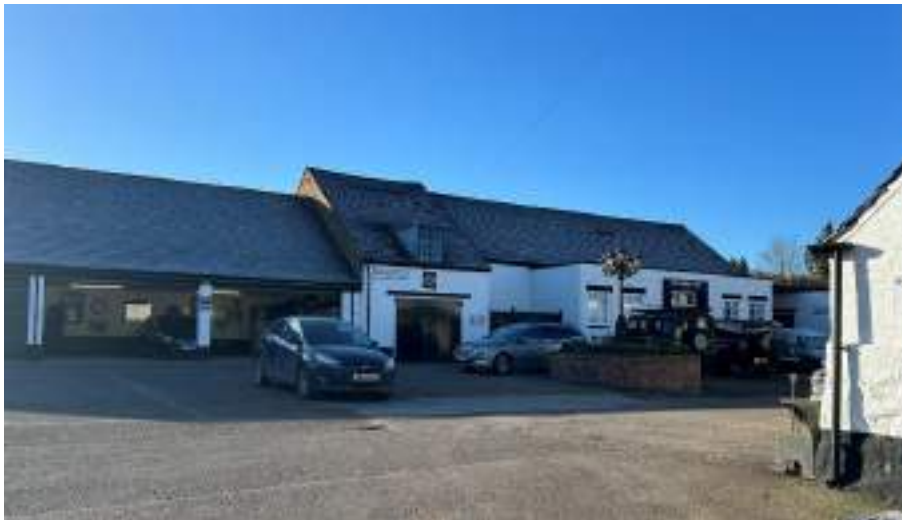
Image 9: The courtyard to the rear of The Shakespeare.

- 7.8 The buildings to the rear of The Shakespeare form a courtyard of ancillary structures, formally part of a traditional farmstead. The original agricultural buildings have been altered and some have now been lost. New structures have also been added, however, the simple design and high-quality materials used in these new additions have ensured the character of the former farmyard remains discernible. Worth noting is the stepped ridges of the south-west range which reflects the cumulative nature of the buildings and adds positively to roofscape in this area (Image 8).

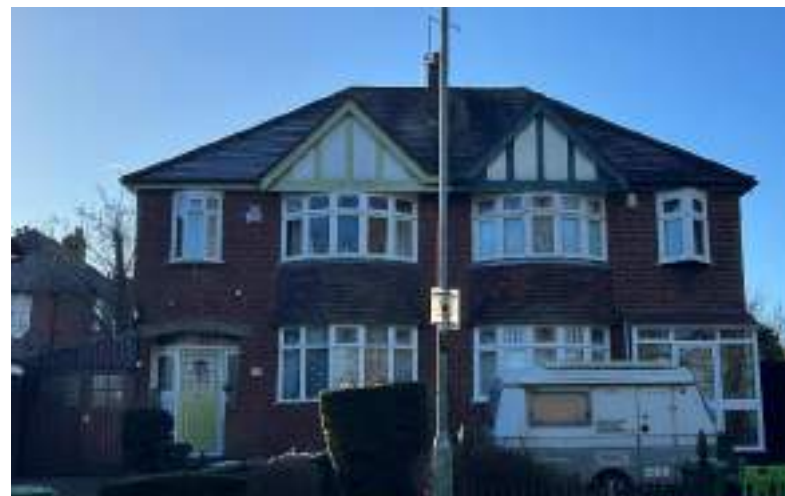
Image 10: 248 & 250 Braunstone Lane.

7.12 Nos **244 – 250 Braunstone Lane** are of a higher architectural quality than the other pair, with sophisticated oriel windows, faux timber framed gables, and double height tile hung bow windows. Almost all the properties retain their original timber joinery which makes an important and positive contribution to their appearance and group value.

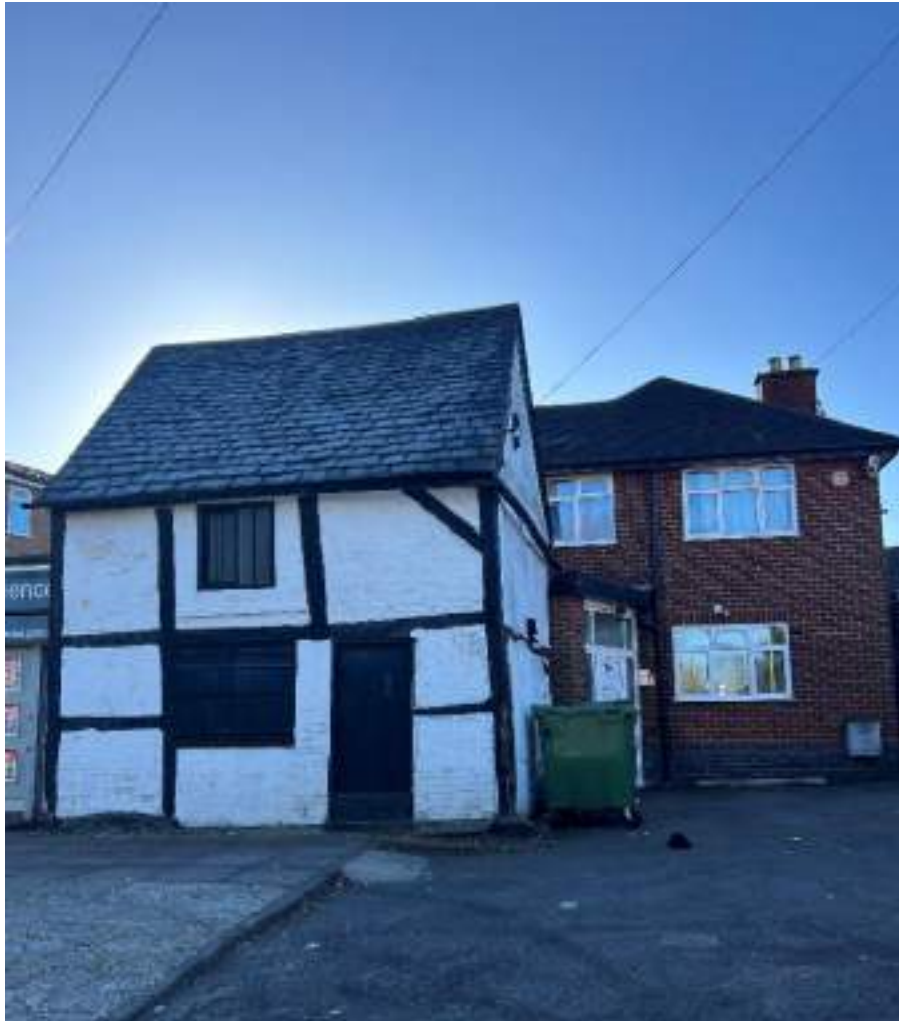
Image 12: Grade II Listed Former Shop with Storage Loft at 266 Braunstone Lane.

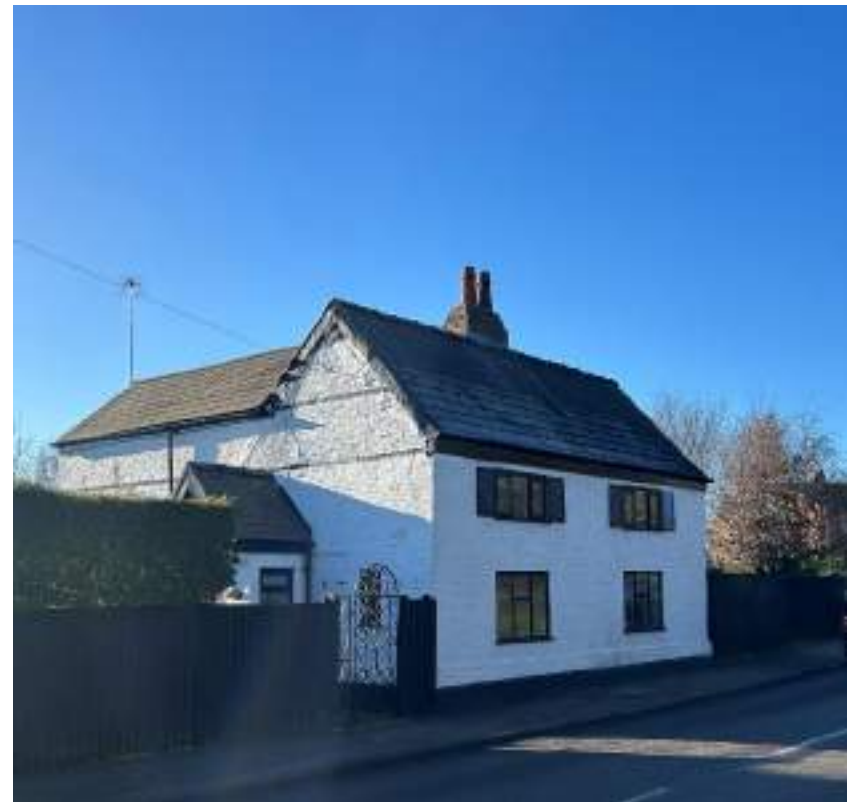
Image 13: Holly Tree Cottage, 278 Braunstone Lane

7.19 **Holly Tree Cottage, 278 Braunstone Lane**, similar to April Cottage, likely represents an older timber framed cottage

which was re-fronted and extended in brick. Evidence of the previous catslide roof is discernible in the northern elevation. Unfortunately, its original openings have been enlarged and modern uPVC windows installed. However, its traditional proportions and construction remain clearly evident, and it retains sufficient historic material to add positively to the character of the area.

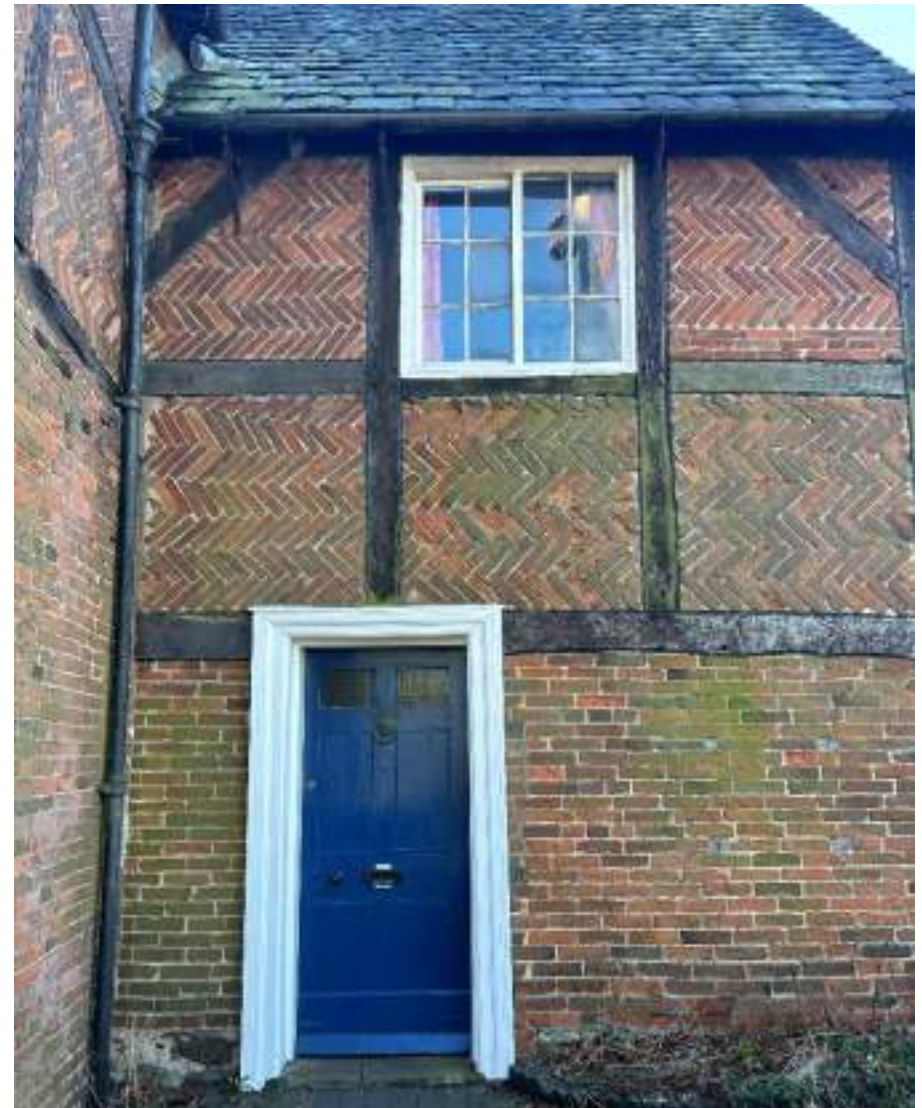
Image 16: The Manor, detail showing herringbone brick pattern, later inserted door and surround and vertical sliding sash window.

7.13 **The Manor** is a timber frame and brick farmhouse, thought to date to the early 17th century with later phases of alterations and extensions. The inscription “16 WPM 89” survives on a horizontal section of the timber frame near the principal entrance. Sited perpendicular to the highway, its principal range is characterised by a prominent gable under a Swithland Slate roof, jettied first floor and later cantered bay window inserted to the ground floor. A secondary range extends north containing an 18th century flush panelled door and moulded architrave crudely cut into the beam above it. A 19th century brick and Welsh slate extension has been added to the rear with a set of four linked chimney shafts. The brink infill is a variety of stretcher bond and

herringbone pattern and there is a mix of window styles throughout the property including both vertical and horizontal sliding sashes. The Manor was Grade II listed in 1952.

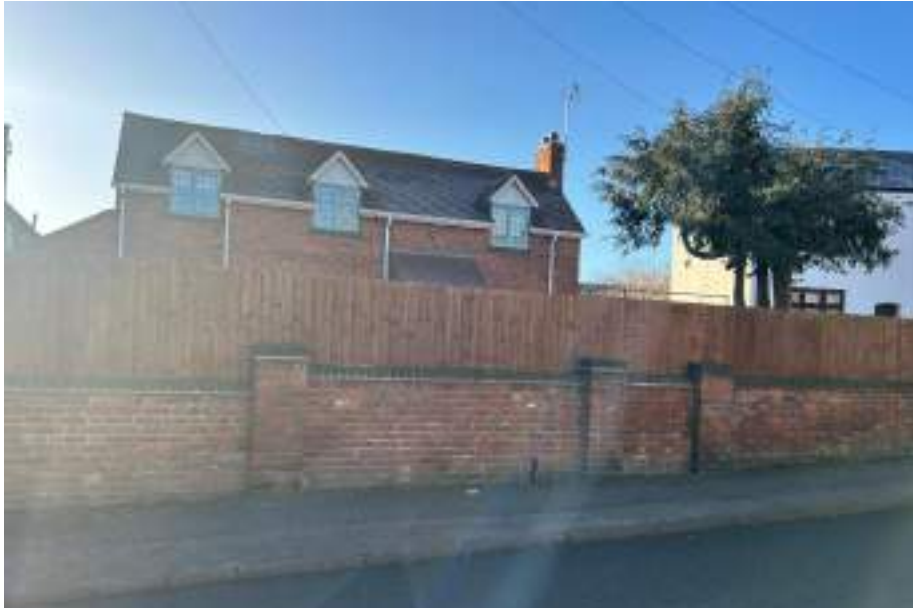
Image 18: Mixture of more and less traditional boundary treatments.

- 9.5 Boundary treatments throughout the Conservation Area vary and range in type, scale, and material, meaning there is a lack of overall consistency and cohesion.
- 9.6 Where present, front boundary treatments in the form of brick boundaries, timber fencing and trimmed hedges, provide a clear definition between the public realm and private property, creating a sense of enclosure and positively contributing to the local townscape. Decorative metal railings and gates are rare within the Conservation Area, with some examples found along Braunston Lane; however, there are instances of modern security fencing used in the vicinity of Shakespeare Park.

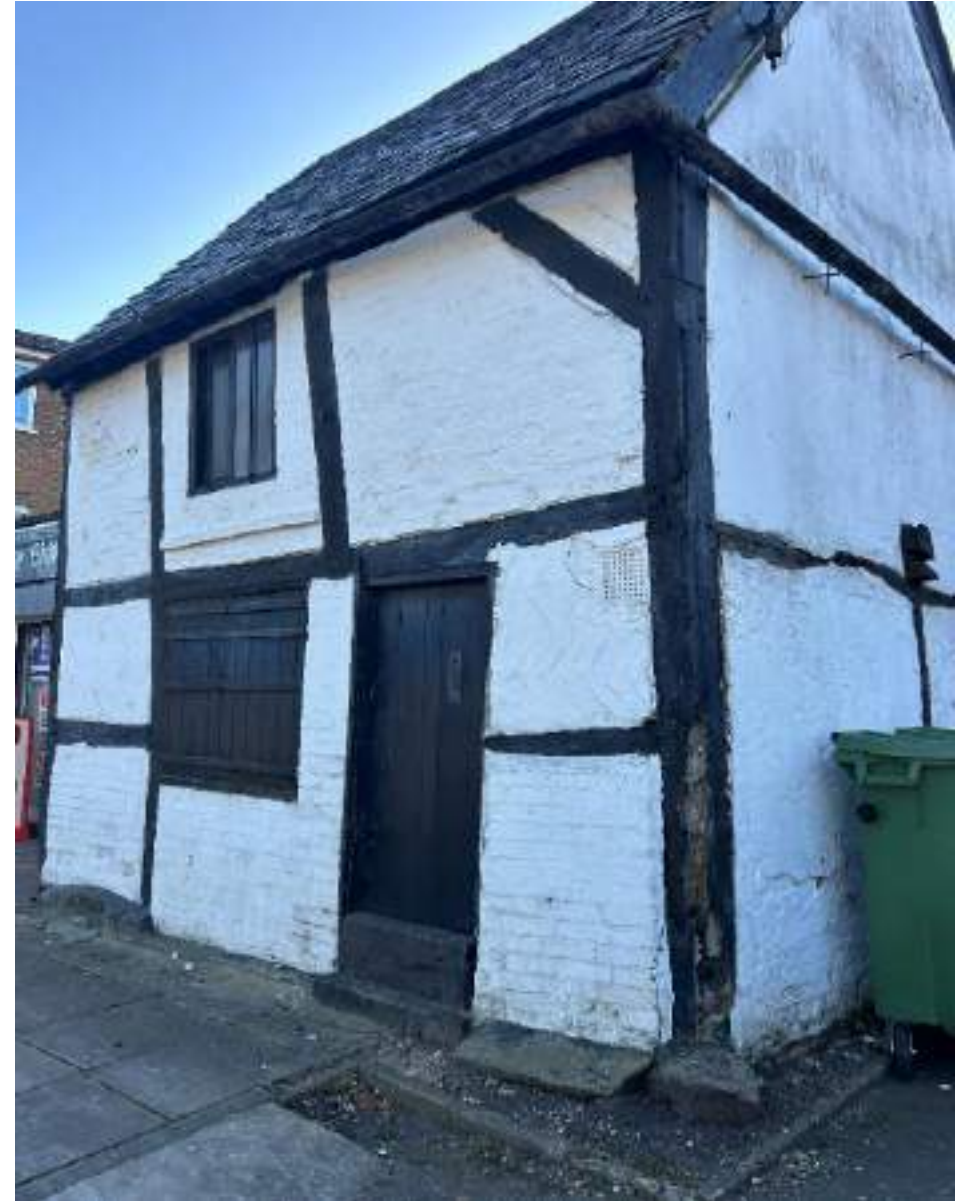
Image 20: Traditional materials use in the building with less cohesive floorscape materials below the plinth.

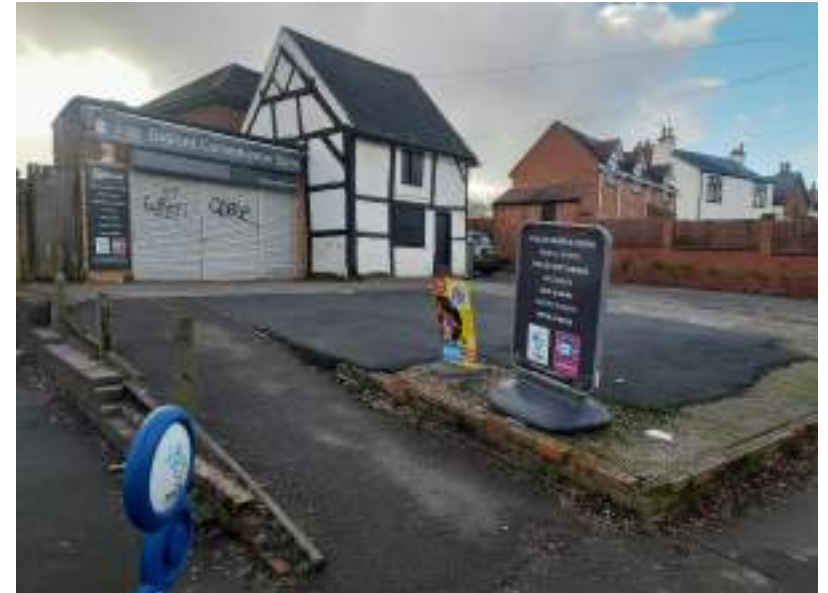
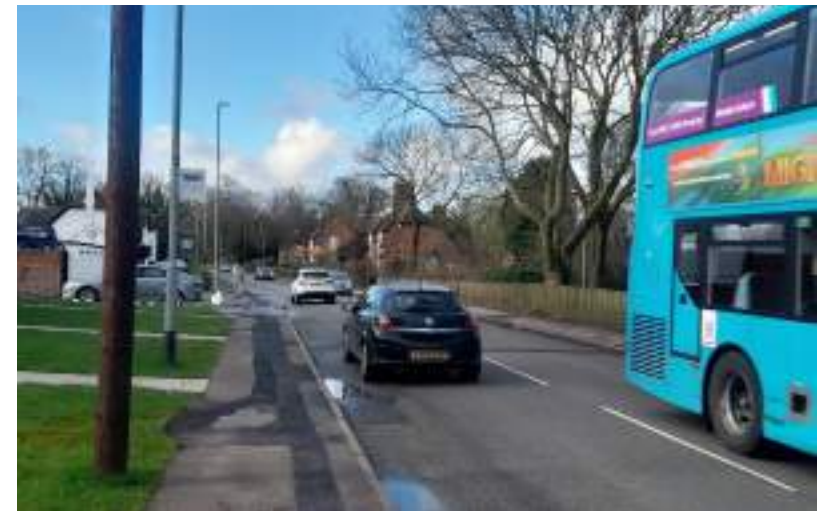
Images 24 & 25: Issues with boundary treatments and hard landscaping, as well as traffic on Braunstone Lane.

- 12.4 The inconsistent boundary treatments throughout the Conservation Area have already been noted but are worth highlighting as negative factors affecting the character of the area. Despite its compact size, the disparity of front boundaries is prominent, especially along the main thoroughfare of Braunstone Lane. Not only are the boundaries different in height, design, materials, and finish, but they are often incomplete, with notable 'gaps' punctuating the streetscene. This has caused visual disconnection between properties and obscured the definition of the private and public domain.

- 12.5 Traffic can dominate Braunstone Lane and make the experience for pedestrians and cyclists less comfortable. Sections of public pavement and highway along Braunstone Lane are in poor condition. In particular, the junction of Bidford Road, and the parking and forecourt area associated with 266 Braunstone Lane is dominated by mixed quality hardstanding. There is poor integration between different sections of hardstanding here, made worse by poor quality boundary treatments.
- 12.6 Commercial signage in this area is also of a more standard **quality** and does not reflect the sensitivity of its historic setting.
